# Maintenance Practices and Costs of Rail-Trails

**rails-to-trails**  
conservancy

**June 2015**

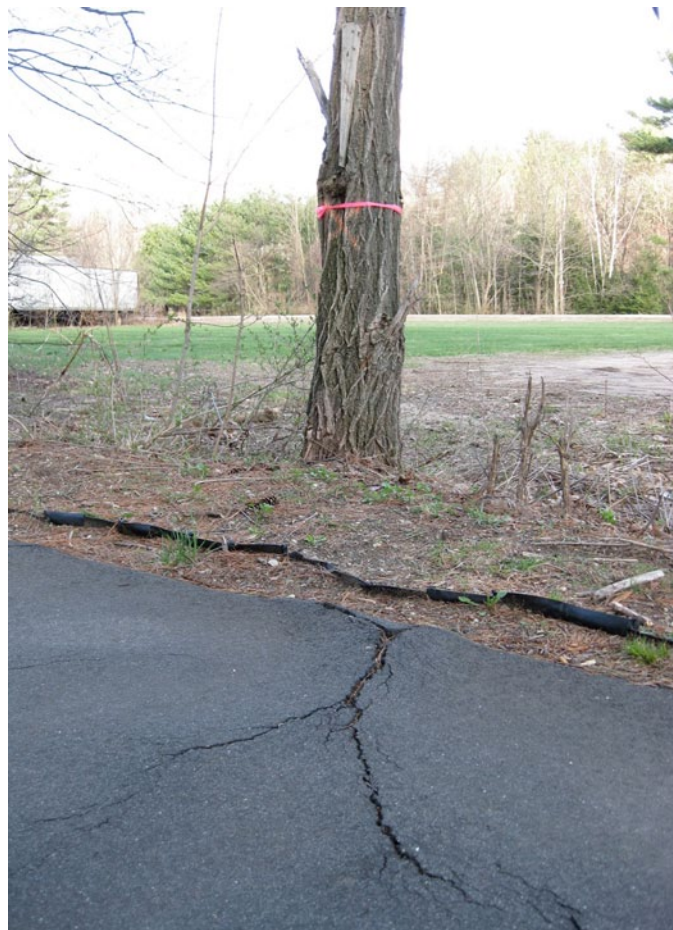
**Tree root damage Manhan Rail Trail, MA.**

New to the 2014 were questions regarding causes of damage to asphalt trails. Survey respondents could list multiple causes of damage. As shown in Figure 7, tree roots are by far the leading cause of damage to an asphalt trail surface at 63 percent. The frost/freeze cycle and water erosion rank second and third, at 44 and 43 percent, respectively.

More than 60 percent of asphalt trail managers reported tree roots as the major source of trail damage. Clearly, as more asphalt trails are being built rather than stone dust trails (as required by some departments of transportation and metropolitan planning organizations); the true costs of these facilities needs to be better understood and shared. Replacing asphalt after several years is costly and frequently becomes a rebuild that is often funded by Transportation Enhancement (TE) programs or Transportation Alternatives Programs (TAP). This costly maintenance requirement might be prevented with better construction standards and possible use of root barriers in certain segments of a trail or periodic trenching to cut root growth. The removal of healthy trees several years after the trail is built is not the only option.

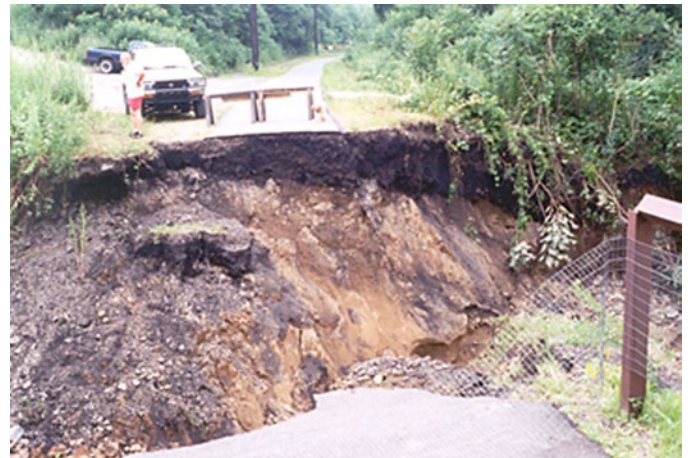
Culvert failure, Allegheny River Trail, PA.

Periodically investing several hundred or even several thousand dollars in maintaining trail drainage systems and culverts can prevent catastrophic damage to a trail when a major water event occurs.

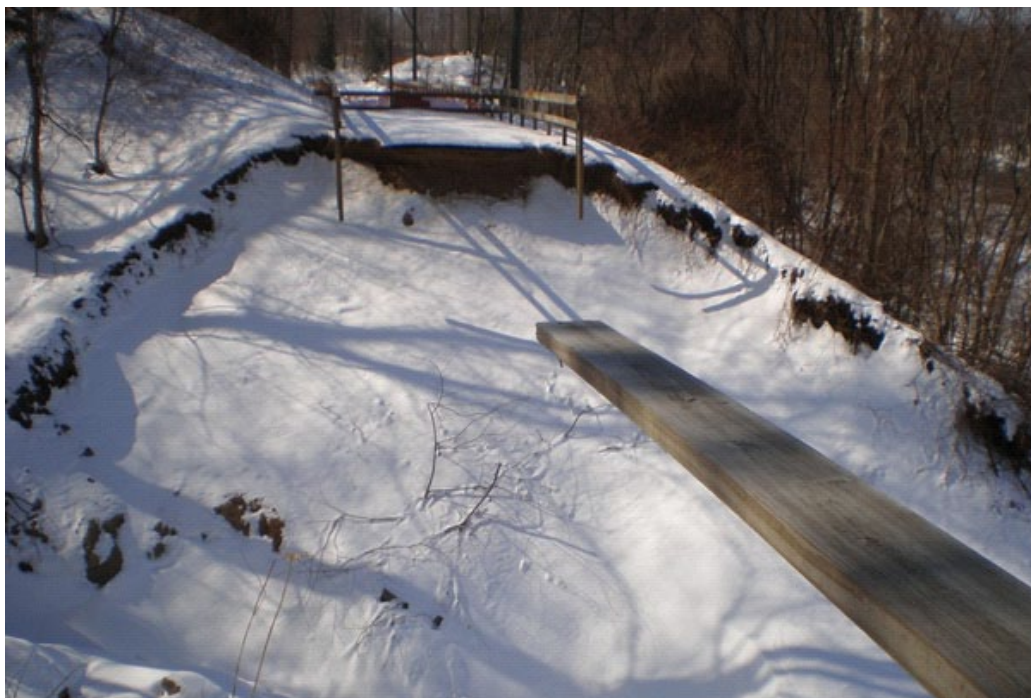
Culvert failure, Manhan Rail Trails, MA.

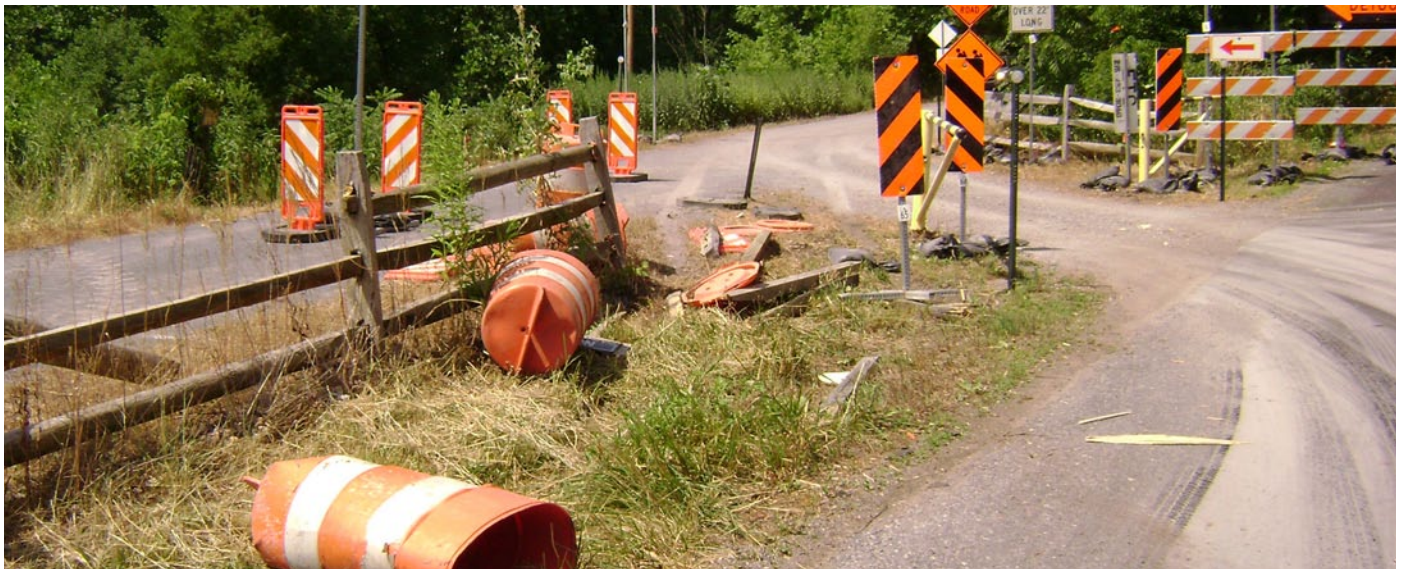
**Damaged split rail fence along the Pine Creek Rail Trail, PA.**

Of these three types, wooden fencing was reported to require the most maintenance. Thirty percent of the detailed cost survey respondents reported time repairing wooden fencing. This maintenance can take the form of replacing fencing that had rotted or fencing that had been damaged by accident or acts of vandalism. Only 8 percent of respondents reported repairs to chain link fence. No respondents reported repairs to vinyl fencing.
